ARBORIST REPORT ELK GROVE, CA

January 17, 2022

Re: Elk Grove High School Root Crown Inspections

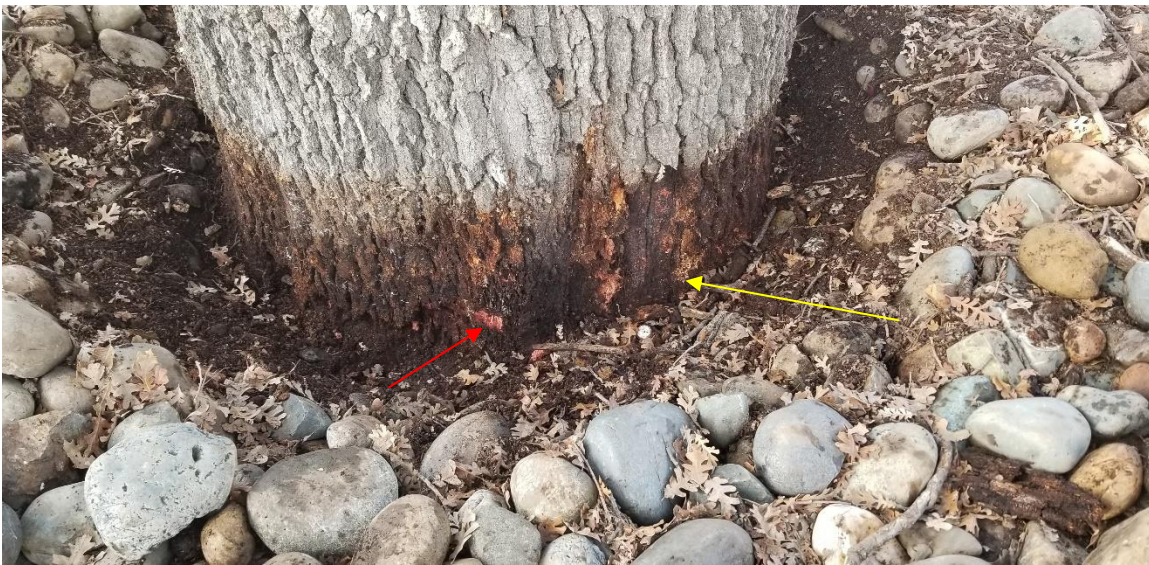
Yesterday I excavated the cobble back from the trees and revealed that the root flares were located 2-3 feet below grade level and sitting in standing water. Consequently, when the High School was built in 1964, these oaks resided at a natural grade 2-3 feet lower, and they had to raise the grade during the development of the school grounds. Oak trees, in general, do not tolerate their root collars being buried by an additional 2-3 feet of soil. An arborist most likely back in 1964 recommended that the trees be backfilled with cobble to prevent the root rots associated with raising the grade around oaks. I believe this method has been somewhat successful, albeit in the short run. At this point, 50-60 years later, the trees have begun to succumb to the constant dark wet soil conditions and developed evidence of root rots and root plate shifting.

Depicted in the above photo is the northeast side of tree #154. The red arrow shows an area of healthy pink-colored tissue, whereas the yellow area shows a duller yellow-brown tissue associated with pathogenic root fungus. Bark plates have rotted away from this area as they were in a saturated environment. Notice how I am only approximately 18 inches below grade and have yet to find a root flare or a buttress root.

I recommend removing all three trees due to the buried root flares that impede inspection, the presence of pathogenic root rot, and the potential for root plate shifting in saturated soil conditions. See photos and captions below.

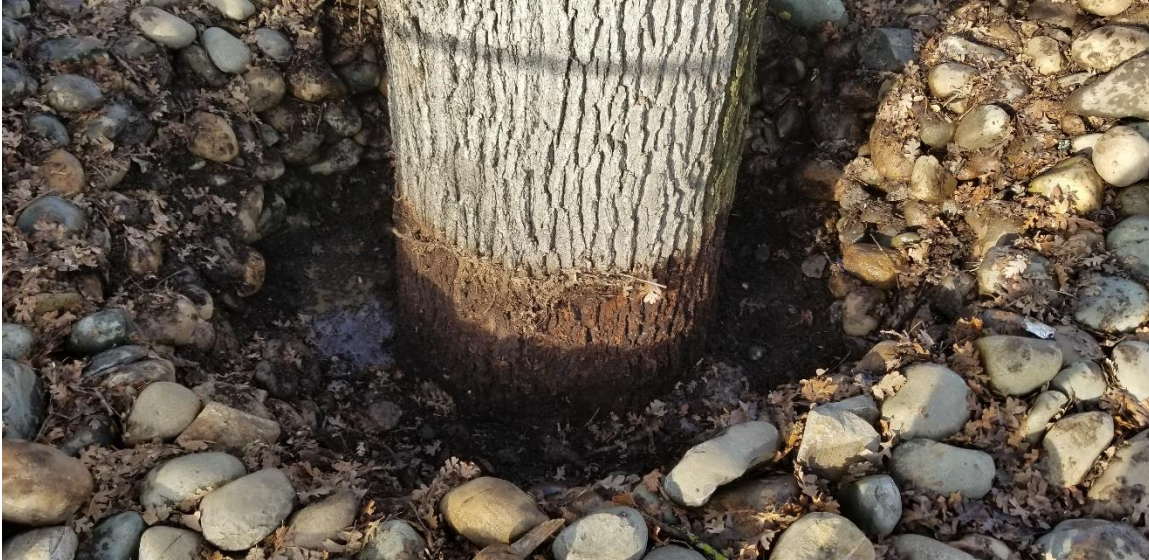
Tree #153 shown above and below has been excavated to approximately 30 inches below soil grade and is sitting in a few inches of standing water.

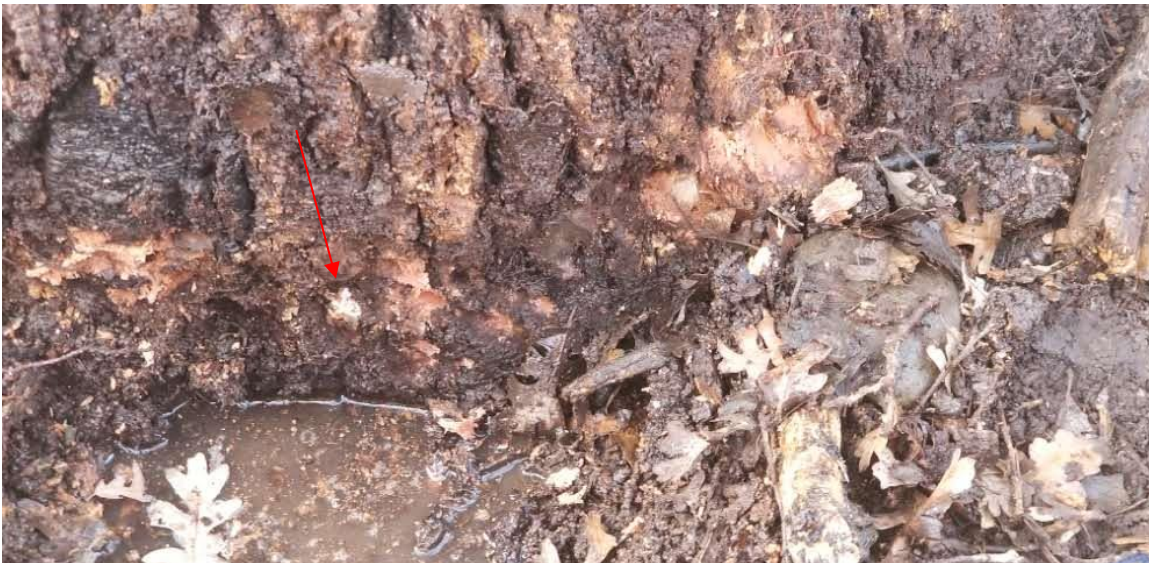
The white spot depicted by the red arrow above was an area of mycelium I found beneath the bark accompanied by the same dull yellow-brown colored sapwood suggesting the presence of pathogenic root rot.

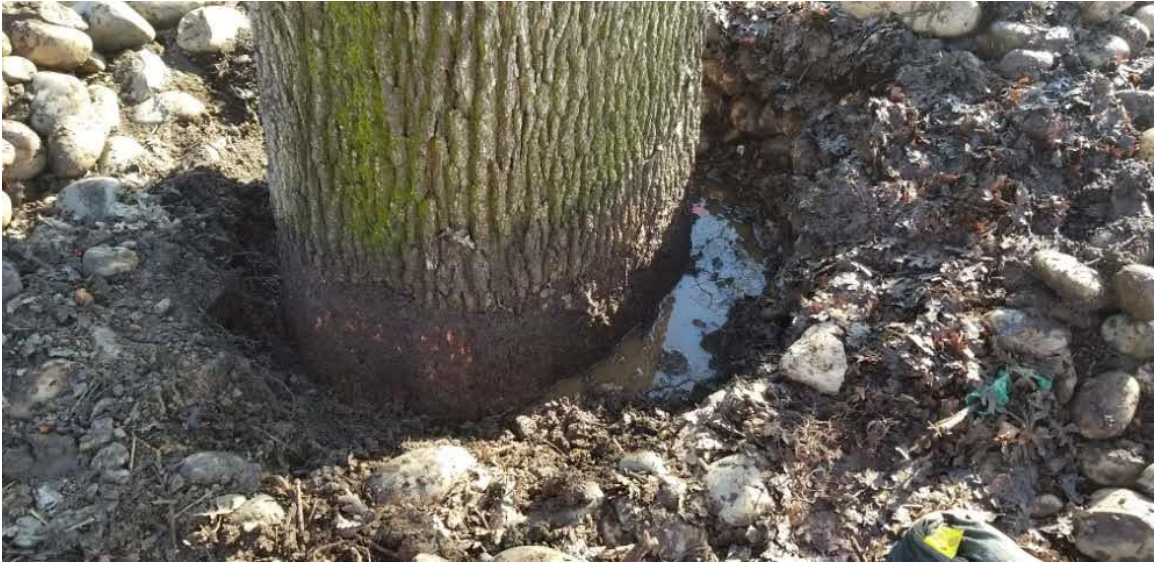
Tree #152, pictured above and below, was also standing in several inches of water. It was apparent that the root plate may have shifted to the southeast. There was some new construction on the adjacent traffic signal on the anchoring side of the tree (northwest) since my inspection in May that may or may not have affected the subject tree’s stability.

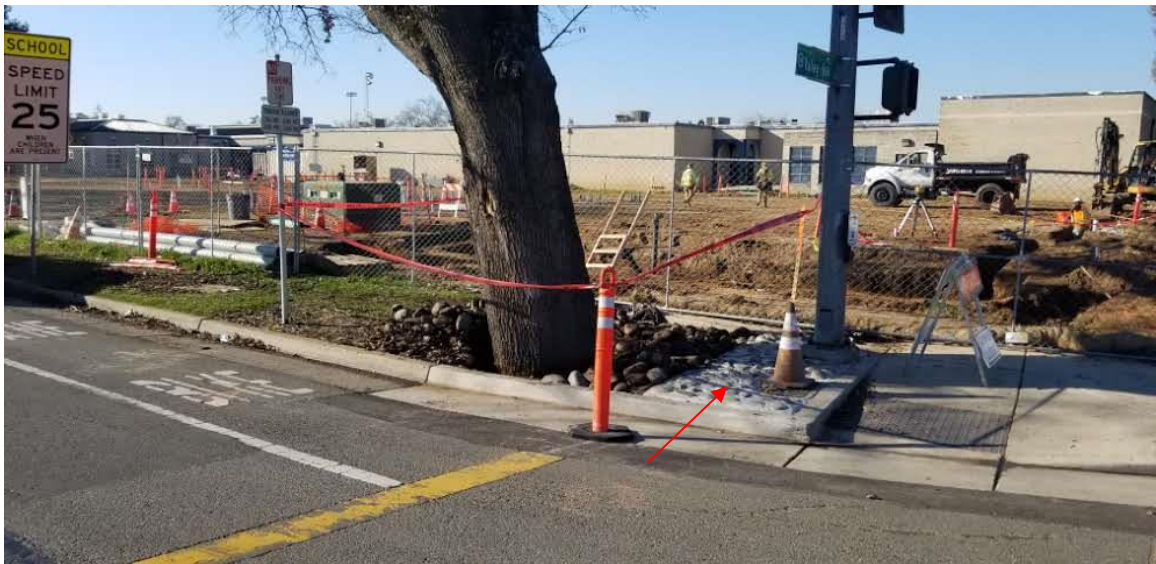
The red arrow depicts the new concrete where some excavation may have been performed. Notice the lean of the trunk to the southeast. In addition, a significant amount of excavation and grading was performed beneath the dripline of the subject tree well within the trees TPZ (Tree Protection Zone) that may have had an additional impact on the subject tree.

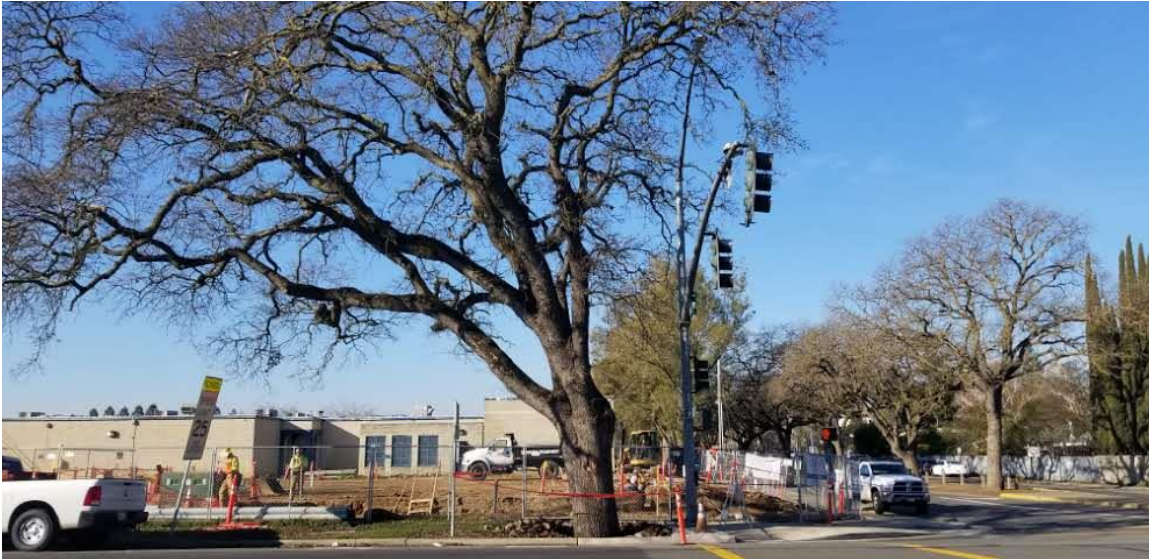
January 2022 Notice the distribution of the canopy and the lean to the south.

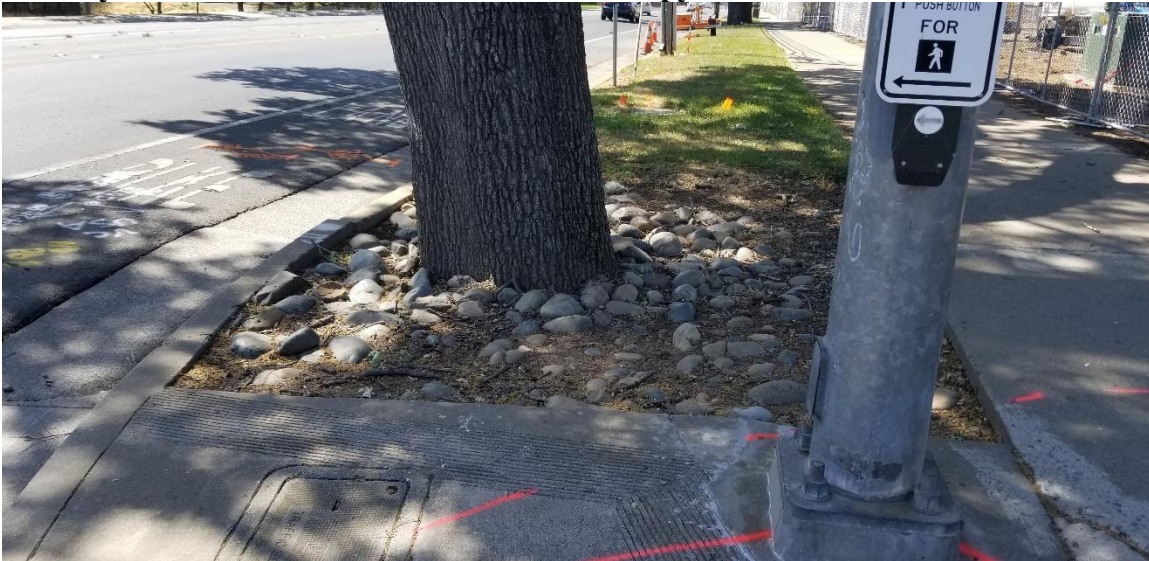
May 2021. Notice there is no cobble embedded in the concrete, as shown in the photo on the bottom of the previous page.
