## ARBORIST REPORT ELK GROVE, CA

Elk Grove Unified School District

**Re:** Elk Grove High School Tree Inspections

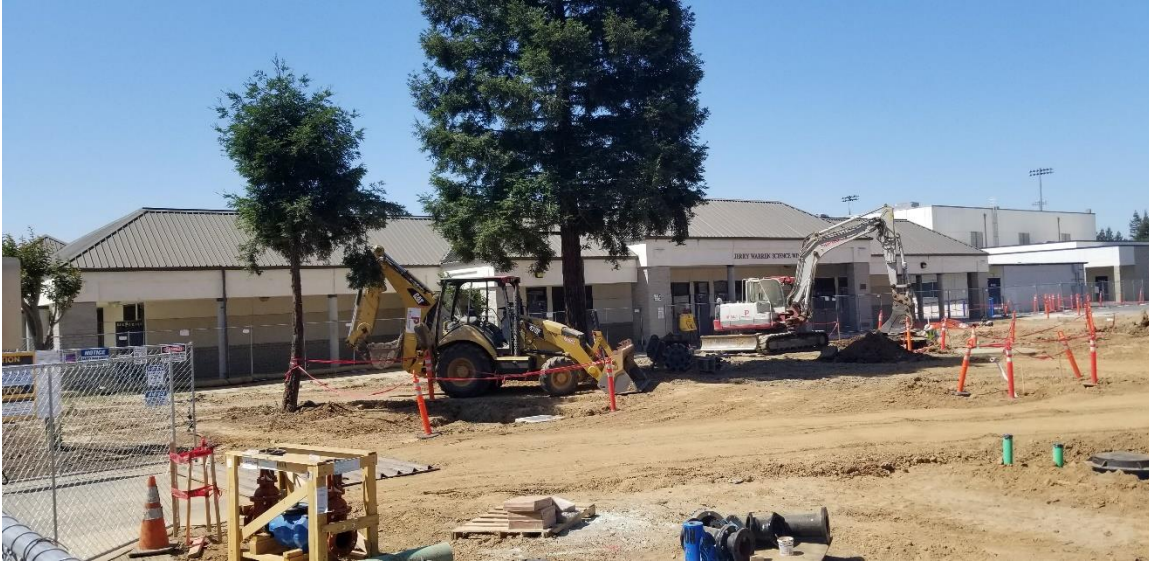
During the demolition of the old landscape in the front of the school, trees that are to be retained in the project were impacted by the construction (see photos in Appendix A). When I visited the site, there were no tree protection zones established. This report does not address the impact to the subject trees #1-11 and the root damage they may have sustained from the demolition and excavation equipment.

**The above photo depicts the absence of tree protection zones (TPZs) and excavation equipment within the critical root zone area beneath the dripline of the canopy.**

Depicted above is the dripline method for establishing a TPZ (Tree Protection Zone) that should be established before the start of any grading, excavation, or construction. Fencing should be sturdy and highly visible to discourage entrance into and disturbing the area. 4-foot-tall orange high-viz plastic net-type fencing is acceptable but not recommended. 6-foot-tall cyclone chain-link fencing is recommended. TPZ barriers should be clearly marked with signs stating the area is protected, and no one can enter or disturb soil without authorization from the project arborist.

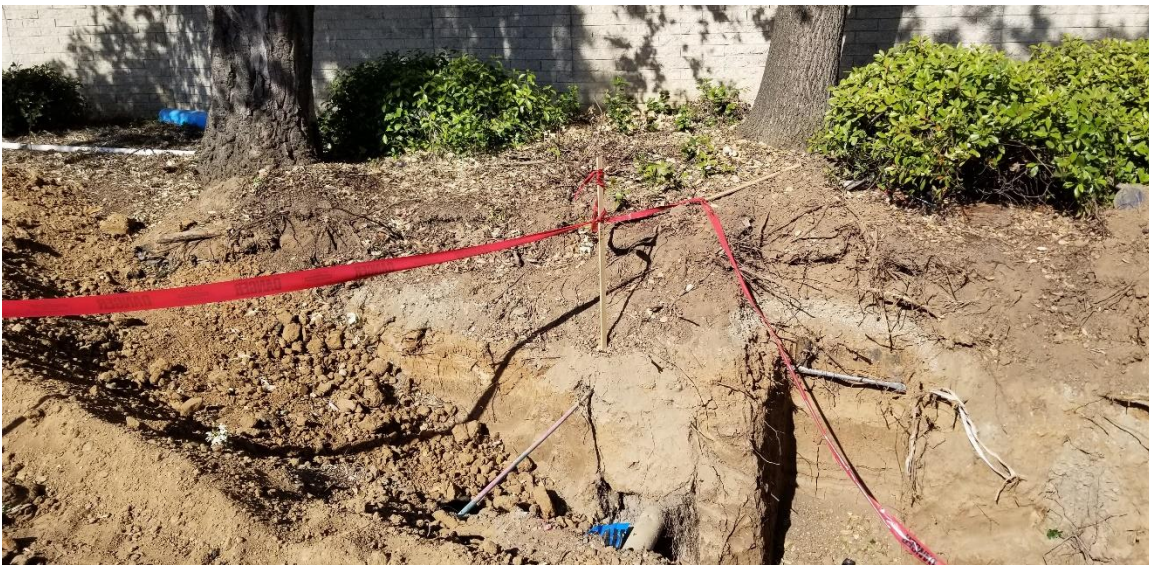
**Several roots were damaged during the excavation performed adjacent to trees #6-7**

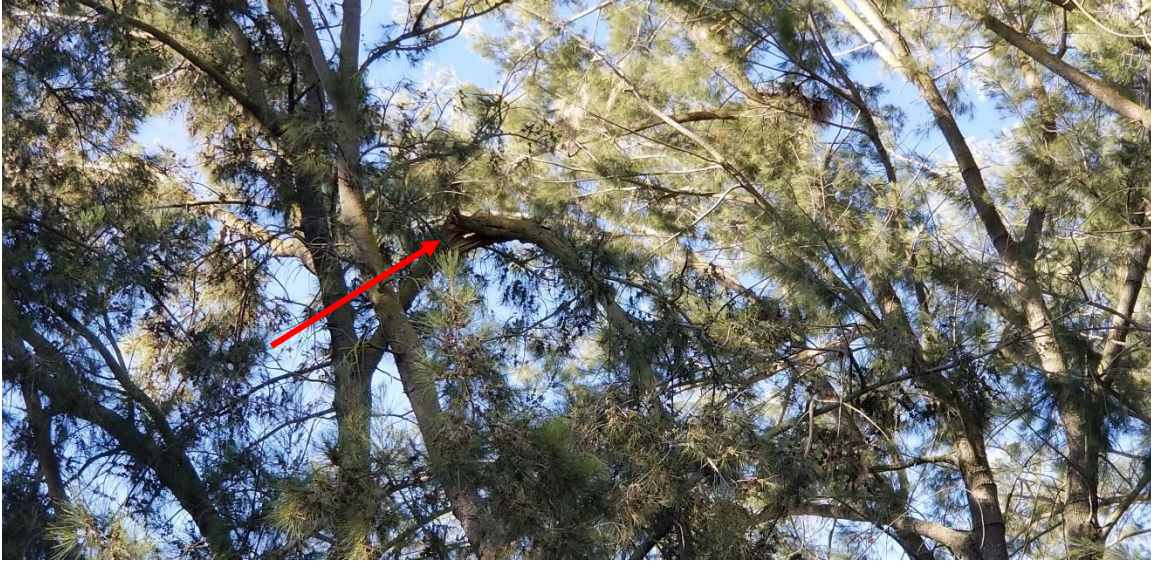
**Beefwood trees #85-118 are in poor condition and have a high potential for branches breaking in adverse weather conditions and otherwise. The red arrow in the above photo depicts a broken, hanging limb in the canopy.**

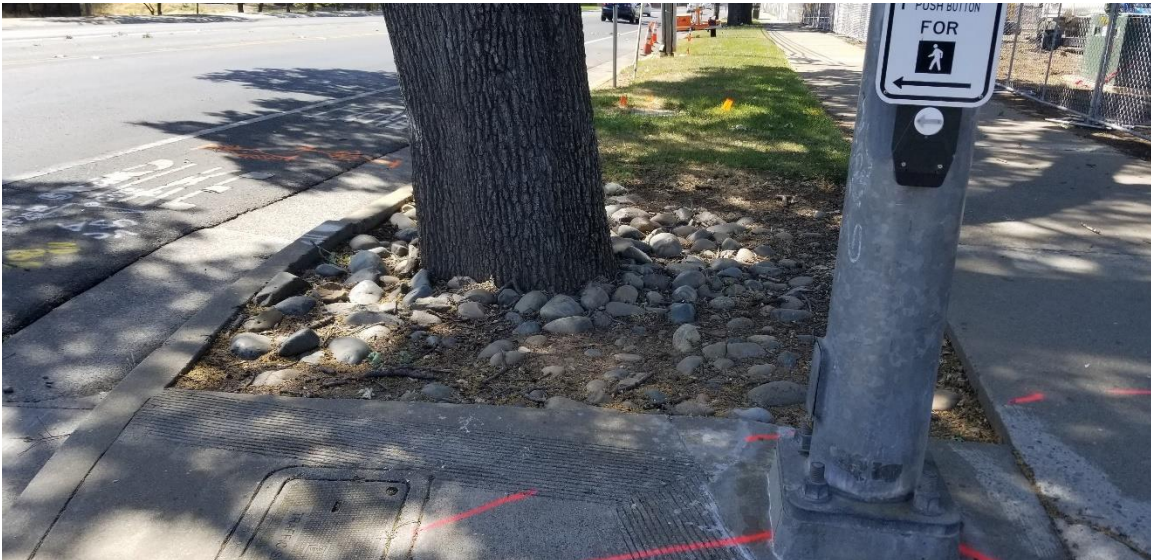
**Valley oak trees #152-154 have an absence of root flare and are buried in cobblestone within the tree well along the public sidewalk area in front of the school. It appears that 3 other trees were in the same planting situation and have either died or fell over due to root rot. I am recommending removing the cobblestone and exposing the root flare to check for pathogenic root rot. A report documenting the findings from the root crown examinations will be included if the School District desires this service.**

**Tree #152 above has an absence of root flare, and the root collar appears buried by the cobblestone. In addition, the USA (Underground Service Agency) markings beneath the dripline suggest the utility trenches may need to be accessed, which would result in root damage to the subject tree. An ISA certified arborist should be present to observe the excavation beneath the dripline and evaluate the extent of the damage.**

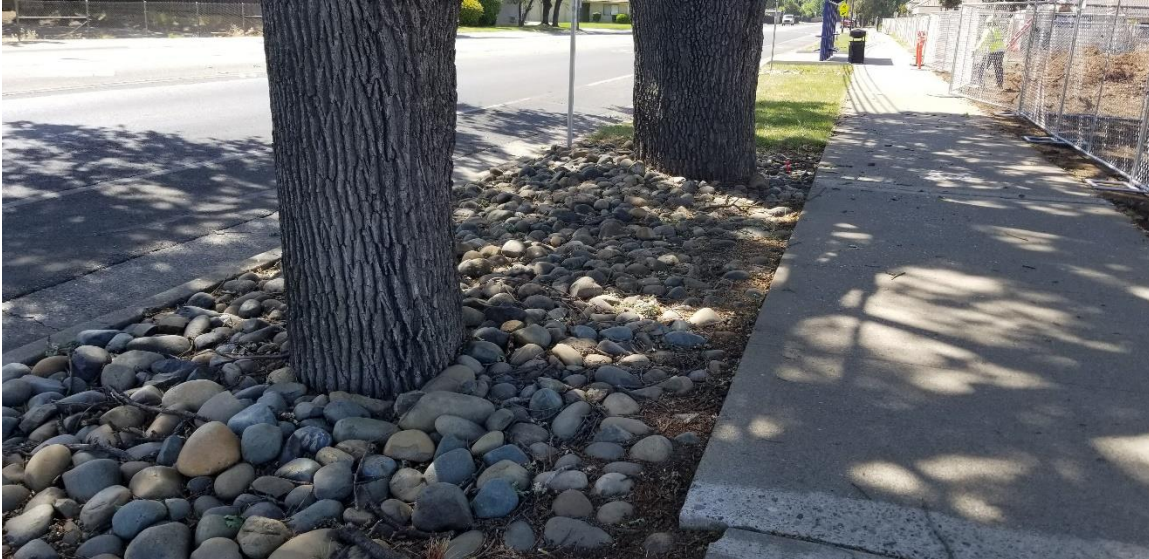
**Trees #153 and #154 are in the same situation as the previous photo but do not appear to require utility trenching beneath their canopies. I recommend removing the cobblestones from around the base of all three trees and exposing the natural grade of the root flare, and checking for signs of pathogenic root rot.**

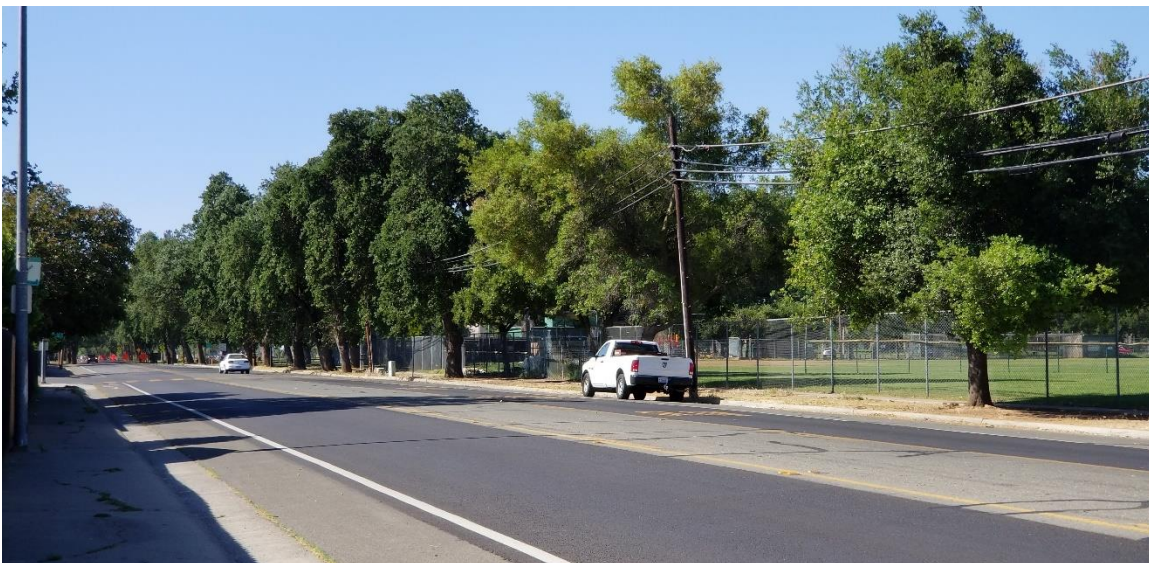
**Trees #155-168 are all in need of immediate pruning to reduce the wood weight and the foliage of overextended lateral branches.**

**All trees with the recommendation "Trim-Poorly Structured" should have a 15% crown reduction performed on the entire canopy as well as branch end-weight reduction pruning on heavy lateral limbs overburdened with foliage and wood weight. Crown clean all dead branches 2" in diameter and larger from the entire canopy. While aloft inspect the crown for any cracks, splits, cavities, or decay, I could not identify from my visual inspection from ground level. All pruning must be directed by myself or a certified arborist in good standing with the International Society of Arboriculture.**
