## ARBORIST REPORT ELK GROVE, CA

Elk Grove Unified School District

**Re:** Elk Grove High School Tree Inspections

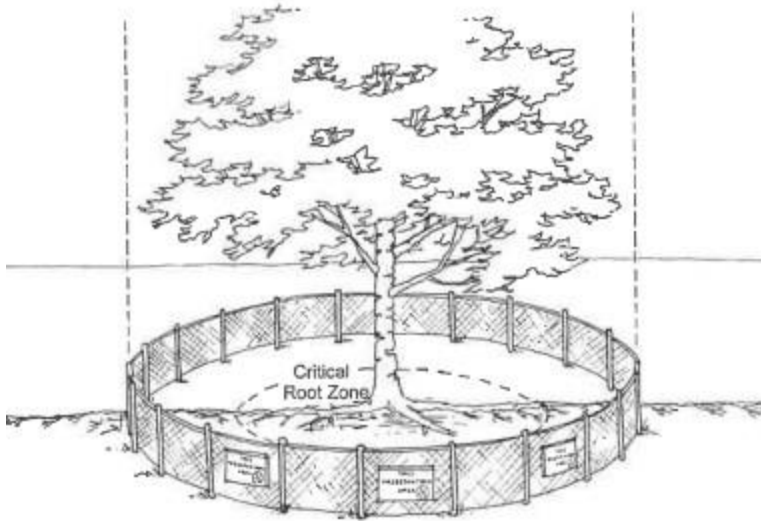
During the demolition of the old landscape in the front of the school, trees that are to be retained in the project were impacted by the construction (see photos in Appendix A). When I visited the site, there were no tree protection zones established. This report does not address the impact to the subject trees #1-11 and the root damage they may have sustained from the demolition and excavation equipment.

Depicted above is the dripline method for establishing a TPZ (Tree Protection Zone) that should be established before the start of any grading, excavation, or construction. Fencing should be sturdy and highly visible to discourage entrance into and disturbing the area. 4-foot-tall orange high-viz plastic net-type fencing is acceptable but not recommended. 6-foot-tall cyclone chain-link fencing is recommended. TPZ barriers should be clearly marked with signs stating the area is protected, and no one can enter or disturb soil without authorization from the project arborist.
